## DAMAGE TO THE HEAT EXCHANGE SURFACE OF STEAM GENERATOR PGV-1000

*S.V. Gozhenko, Y.O. Krainiuk, A.S. Mitrofanov*

*National Science Center “Kharkov Institute of Physics and Technology”, Kharkiv, Ukraine*

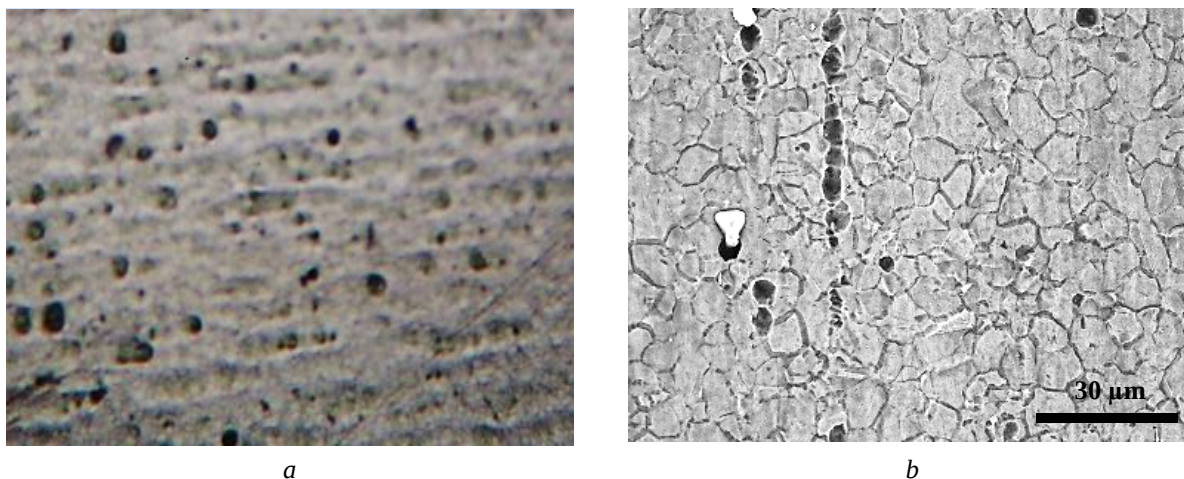
The width and depth of the grooves is 2–3 metal grain sizes and is about 10 μm. The microstructure of the steel is austenitic, the grains in the longitudinal and transverse directions of the pipe are equiaxed.

In the longitudinal section of the pipe, the metal has a pronounced uniform striped (line) structure, in which short, fragmentary lines of a dark color are randomly located. The line structure is formed during the rolling of steel due to the presence of inclusions in it, in particular, globular (< 1 μm) and faceted (2...5 μm). Plastic inclusions (oxides, sulfides) are deformed together with the matrix metal and form discontinuous interlayers; hard and brittle non-metallic inclusions, such as titanium nitride (see Fig. 1), do not deform and are pressed into the matrix metal, or split and displace in the rolling direction.

Fig. 1. Surface of HET. "Wavy" austenitic microstructure of steel (a), electrolytic etching (b)

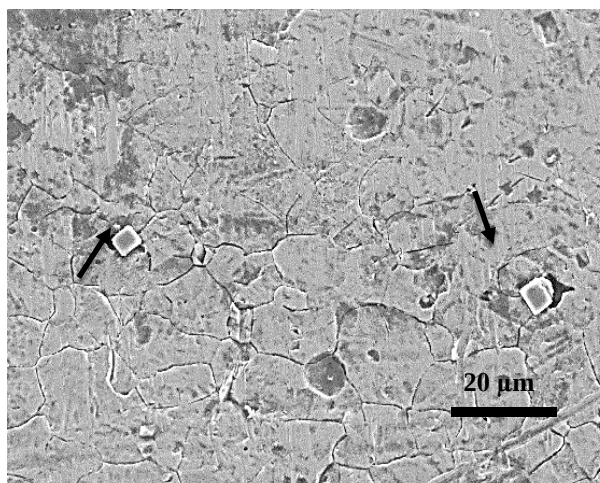
It should be noted that titanium nitride inclusions are observed both on the HET surface and in their body (Fig. 2).

Fig. 2. Inclusion of titanium nitride in HET metal

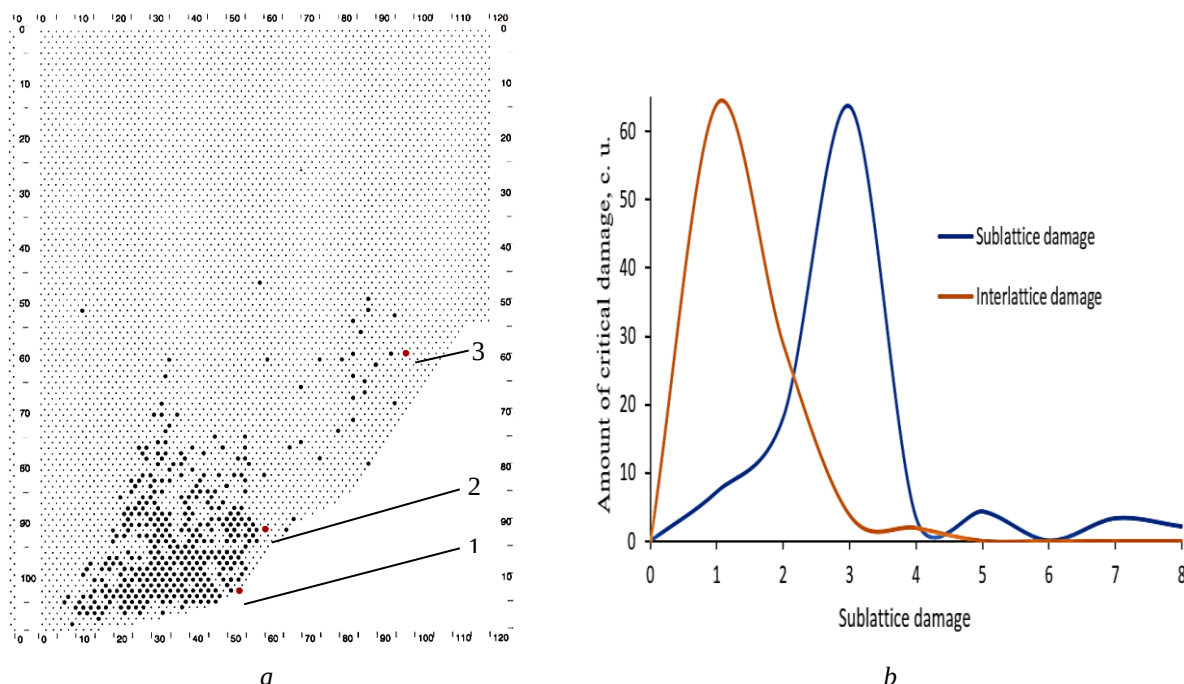
Fig. 3. Distribution of critical HET damage near the "hot" collector of SG 1 (a – transverse; b – longitudinal)

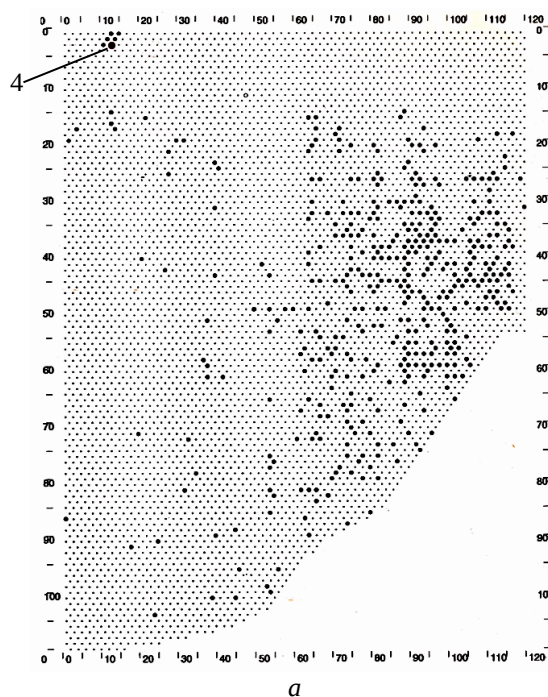
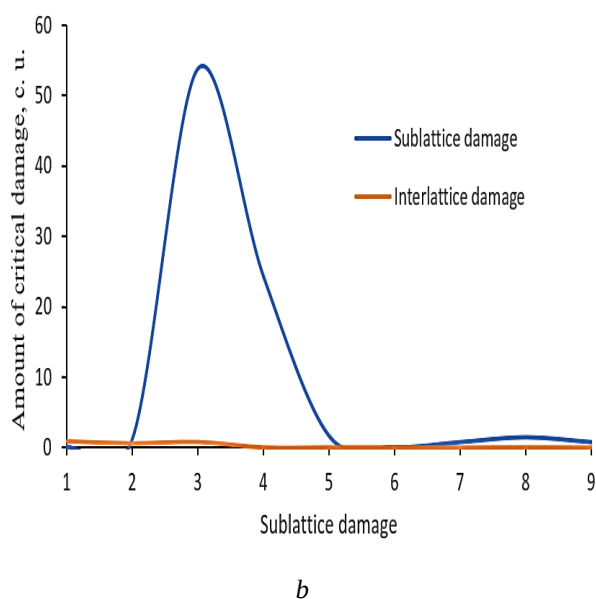
Fig. 4. Distribution of critical HET damage near the “hot” collector of SG 2 (a – transverse, b – longitudinal) in the zone of the greatest damage to the HES

It should be noted that SG, the distribution of HET damages of which is shown in Figs. 3 and 4, were simultaneously operated at the control room of the NPP under the same conditions. In most cases, deposits on HET are black powdery deposits up to 0.1 mm thick. In some cases, especially in the area close to the bottom of the SG – up to 0.8 mm. Deposits often do not form a continuous coating, they can be separated flakes, the exfoliated part of the deposits enters the sludge (Fig. 5).

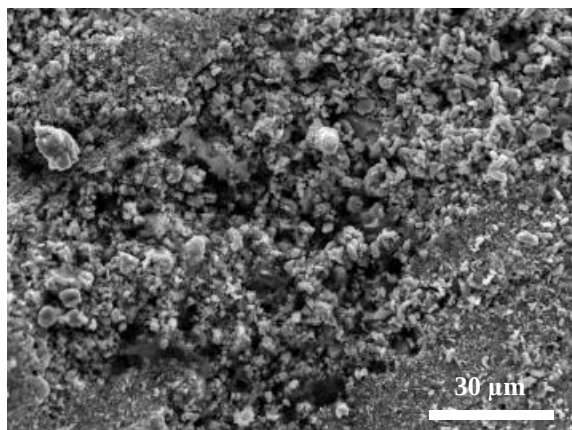
Fig. 5. A flake of sediments exfoliated from the HET

Fig. 5 shows that at least some components of the deposit were formed in a liquid medium and settled on the HET already in the formed form.

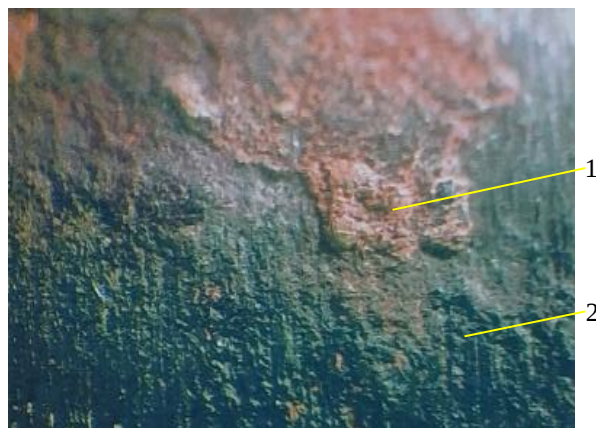
There are deposits of black color, relatively dense. The main element of these deposits is iron (as well as chromium, nickel, ...), in the form of mixed oxides (the ratio of the elements varies depending on the position of the control zone and water-chemistry condition (WCC) of the second circuit). Chemical analysis showed that in some deposits the copper content can reach 50%. There is also an overlay of layers with high content of metallic

copper particles (Fig. 6, position N 1) on black sublayers of deposits based on iron oxides (see Fig. 6, position N 2).

Fig. 6. A layer of deposits on the HET in the lower part of the SG (see Fig. 3,a, position N 1)

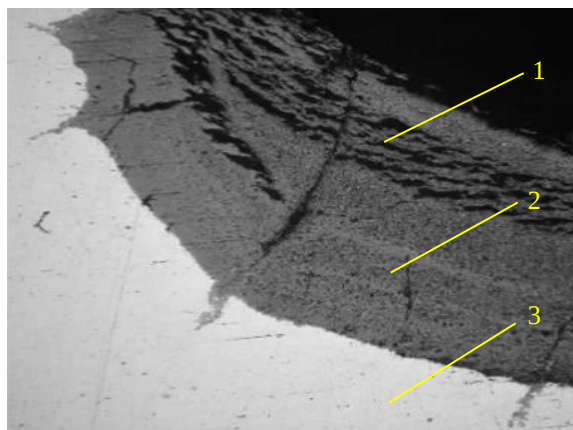
Under the deposit layer, as a rule, metal corrosion is observed in the form of pits filled with corrosion products (Fig. 7).

The formation of pits is due to the processes of electrocorrosion that occur when the surface of the HET metal comes into contact with sludge particles containing copper [3].

Fig. 7. Corrosion pit on the surface of HET:  
1 – layer of porous corrosion products;  
2 – layer of dense corrosion products;  
3 – body of HET

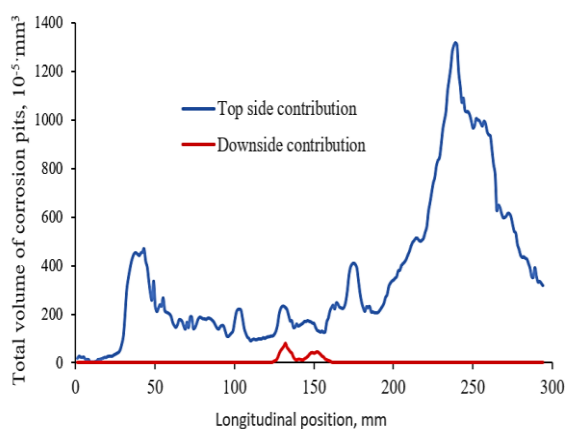
Accordingly, the total volume of these pits is increased on the surface, where there are more sludge particles (Fig. 8).

Fig. 8. Total volume of pits of the HET segment from the lower part of the SG with the initial hydrodynamic regime (see Fig. 3,a, position N 1)

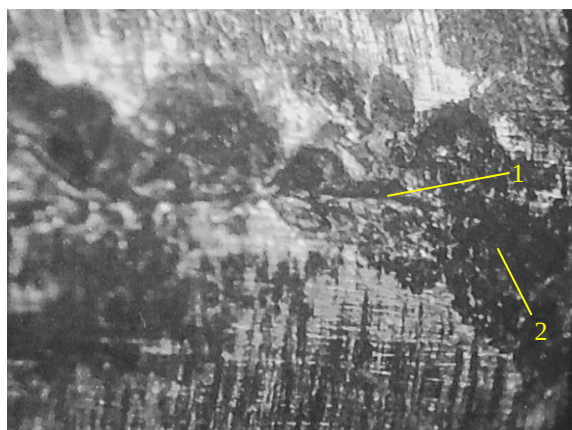
In most cases, the appearance of pits does not lead to critical destruction of HET. But, under the action of stresses (initial or due to the filling of pits with corrosion products), stress corrosion cracking of HET is possible (Fig. 9).

Moreover, the cracks are oriented along the axis of the pipe, what makes it impossible to completely break the HET.

Fig. 9. Cracking of HET under the stress in the area of corrosion pits:  
1 – crack; 2 – corrosion pit

This is most often observed in the zone of sludge accumulation (in particular, in the zone of position N 1 (see Fig. 3,a)) near the “hot” collector.

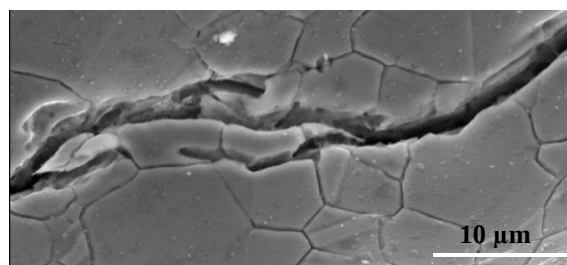
under the influence of alternating HET loadings. In this case, the destruction processes initiate both corrosion damage and defects in the metal. The destruction of HET, which is due to metal fatigue, in most cases begins with a corrosion pit. This, in particular, confirms the fact that the number of such damages falls with the improvement of WCC. In zones with low levels of deposits, such as in the upper sections of the heat exchange surface (sample location zone 4 (see Fig. 4,a)), damage appears as a closed crack. Damage to the metal is manifested by eddy current inspection of HET. At room temperature, these types of damage can be sealed. Capillary inspection does not always detect such damage. At the initial stage of HET damage, such a crack does not contain corrosion products (Fig. 10,a), unlike corrosion cracks (see Fig. 10,b).

Fig. 10. Filling cracks in HET with corrosion products

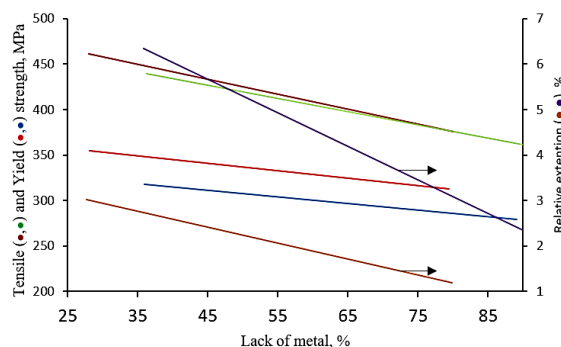
It should be noted that the strength of the HET metal localized around defects tends to decrease with increasing damage depth (Fig. 11), without going beyond the normative values.

Fig. 11. Change in the mechanical properties of the base metal of HET with increasing size of defects:  
—, — and — — corrosion pits; —, — and — — cracks.  
350 °C

This trend persists with corrosion and fatigue damage to the HET.
