## DAMAGE TO THE HEAT EXCHANGE SURFACE OF STEAM GENERATOR PGV-1000

*S.V. Gozhenko, Y.O. Krainiuk, A.S. Mitrofanov*

*National Science Center “Kharkov Institute of Physics and Technology”, Kharkiv, Ukraine*

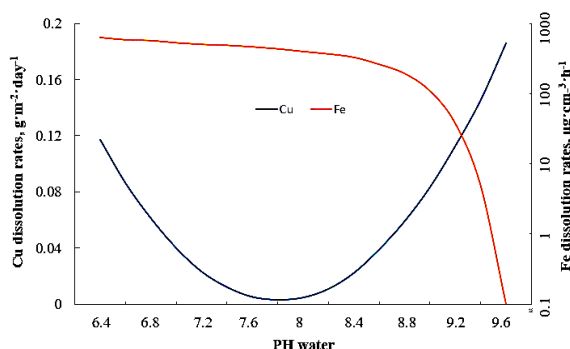
Fig. 12. The entry of corrosion products of iron and copper into water depending on pH [4]

sion of equipment and pipelines in the secondary circuit water. In particular, the WCC was optimized. The main problem of WCC is the presence in the secondary circuit of equipment and pipelines made of materials (chromium-nickel steel (08Kh18N10T), carbon steels (steel 20, 16GS, 10GN2MFA), copper alloy (MNZH5-1)) that require different optimal WCC operation. This is clearly seen from Fig. 12 illustrating dependence of the corrosion rates of the main components of the materials used in the secondary circuit (in particular, copper and iron) on the pH of the water.

At present, it is impossible to completely remove copper alloys from the secondary circuit of operating NPPs; the main areas of work are the improvement of WCC and the prevention of unreasonable HET plugging [5].

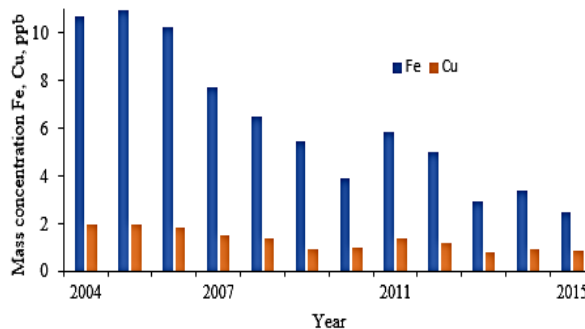
Fig. 13. Dynamic of changes in the content of the corrosion products in the SG feed water [7]

Corrective treatment of the working medium of the secondary circuit with ethanolamine reduces the copper content in deposits by about 3.3 times. At the same time, the iron content increases by about 5%. This is due to a decrease in the concentration of iron and copper in the water of the secondary circuit. Fig. 13, as an example, shows the decrease in their concentrations in the water of the second circuit power units No 1–4 Rivne

NPP with the start of corrective treatment with ethanolamine.
